Development Plan

845 - 875 Taylors Road, Dandenong South

July 2013

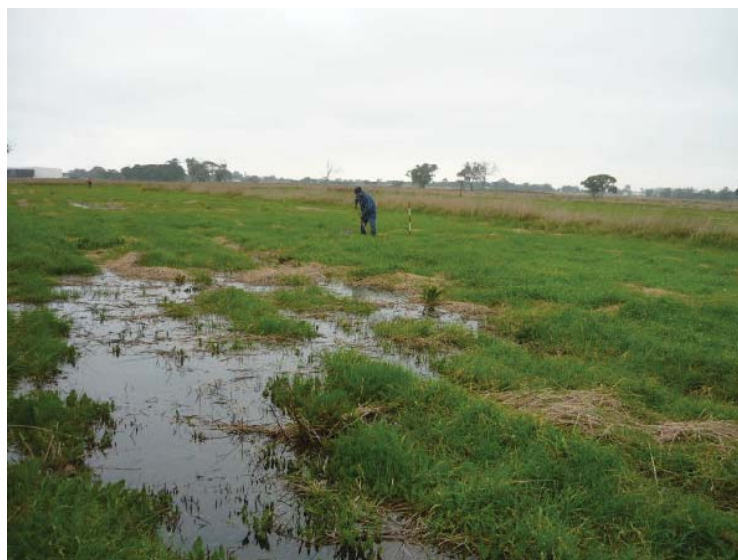
The second phase of the sub-surface testing program was conducted on the 17th and 18th of May 2011 with the aim of testing the low-lying floodplain. The proposed methodology was to conduct a series of shovel probes in a grid across the floodplain at approximately 100 metre intervals, switching to controlled excavations if any cultural heritage was found. However field conditions at the time made this impracticable; as despite the system of drainage channels (both large and small across the area) water was laying ankle deep over much of the area (Photograph 5).

Photograph 5 - Sub-surface testing in area featuring significant levels of surface water

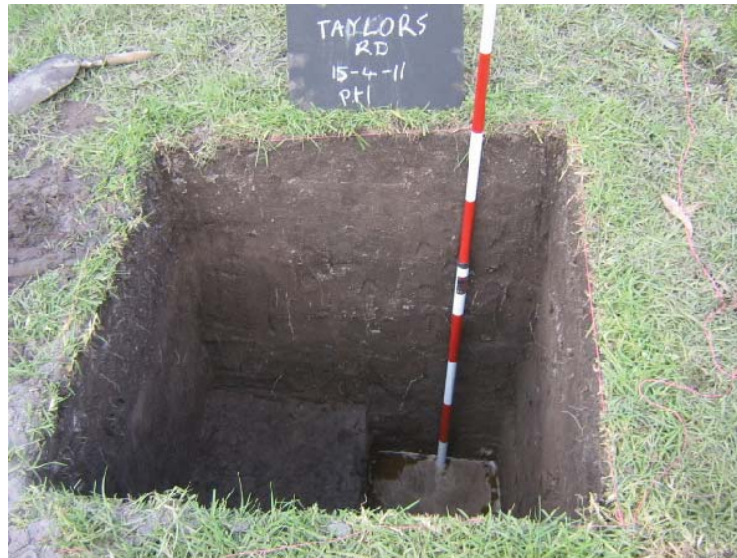
Photograph 6 - Test Pit 1 at completion of excavation

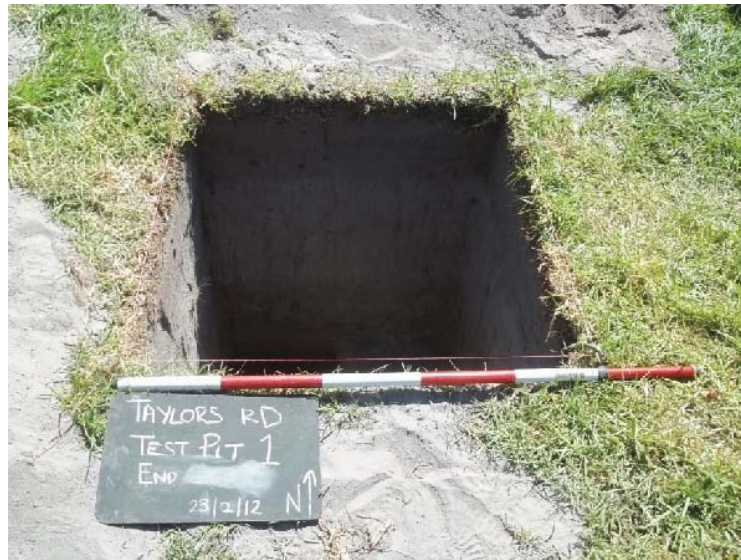
Photograph 7 - TP1 at completion of excavation

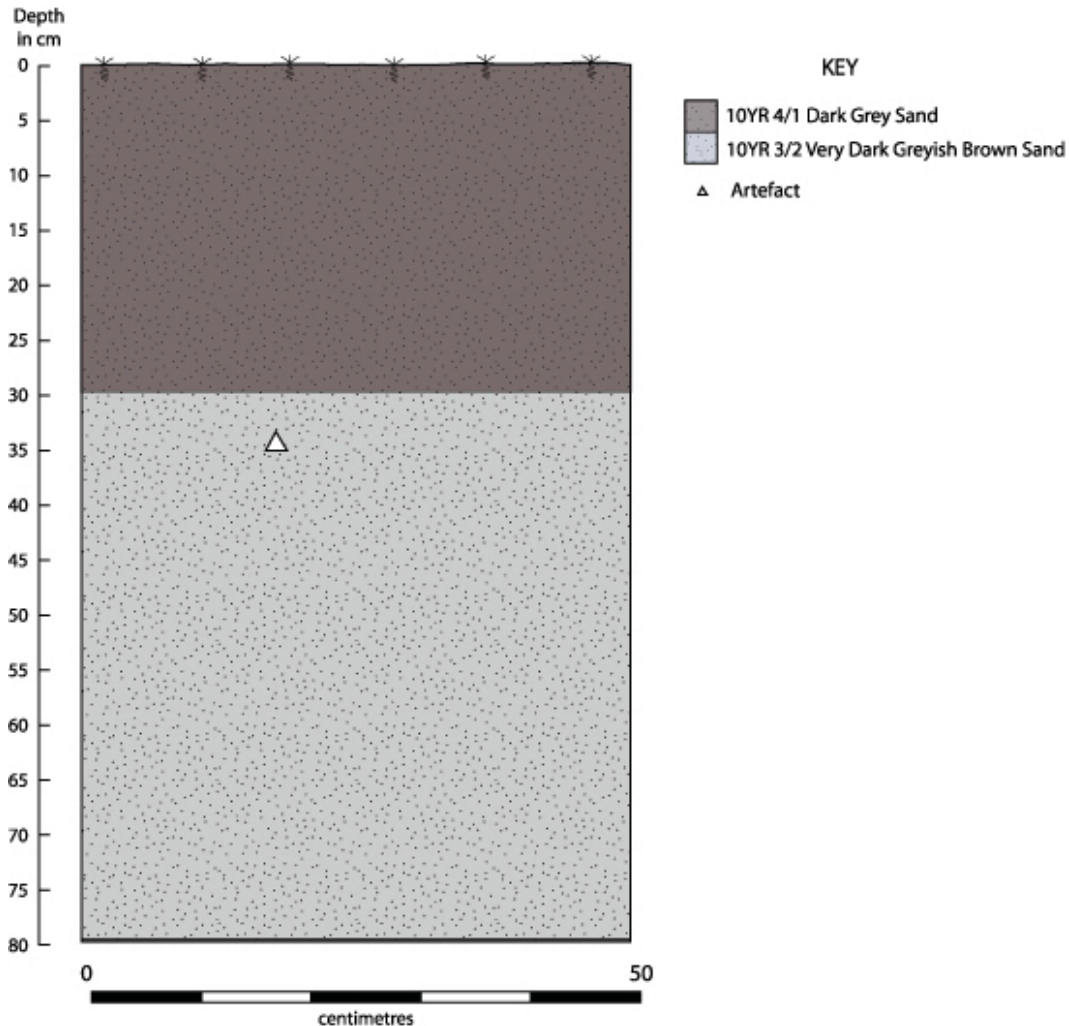
An excavation measuring 50cm x 45cm located 5 metres across the slope (north) from Pit 2. Soil stratigraphy consisted of dark grey sand which extended to 30cm depth, which sat atop a very dark greyish brown sand that darkened in colour and extended to the base of the pit. The water table was reached at 72 cm causing the walls to begin to collapse at the bottom of the pit. The excavation was terminated at 80 cm (Figure 6). A single silcrete flake was found in Spit 4 between 30cm and 40cm.

Figure 6 - **Schematic stratigraphic drawing Shovel Test Pit 4**

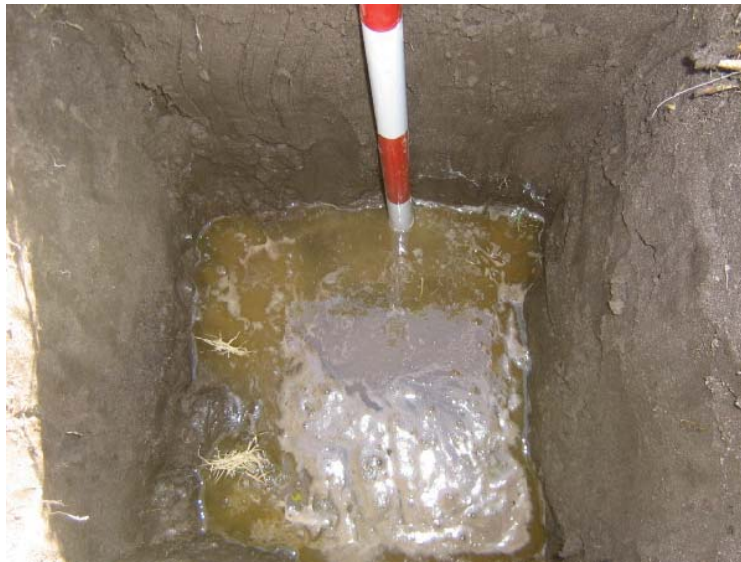
Photograph 11 - Water seepage into Shovel Test Pit 5
