Lot 2 PS603443D, 345-385 Perry Road, Keysborough
Development Plan- 'The Link' Industrial Estate
August 2014

Pursuant to Clause 43.04 Schedule 6 of the Greater Dandenong Planning Scheme this is a copy of the Development Plan for part of the land defined as DPO6 and particularly with reference to the Keysborough Precinct. This Dandenong South Industrial Area Extension Development Plan (No. 11) has been prepared to the satisfaction of the Responsible Authority. Once the Development Plan has been approved by Council, Council retains the sole right to amend the Development Plan.

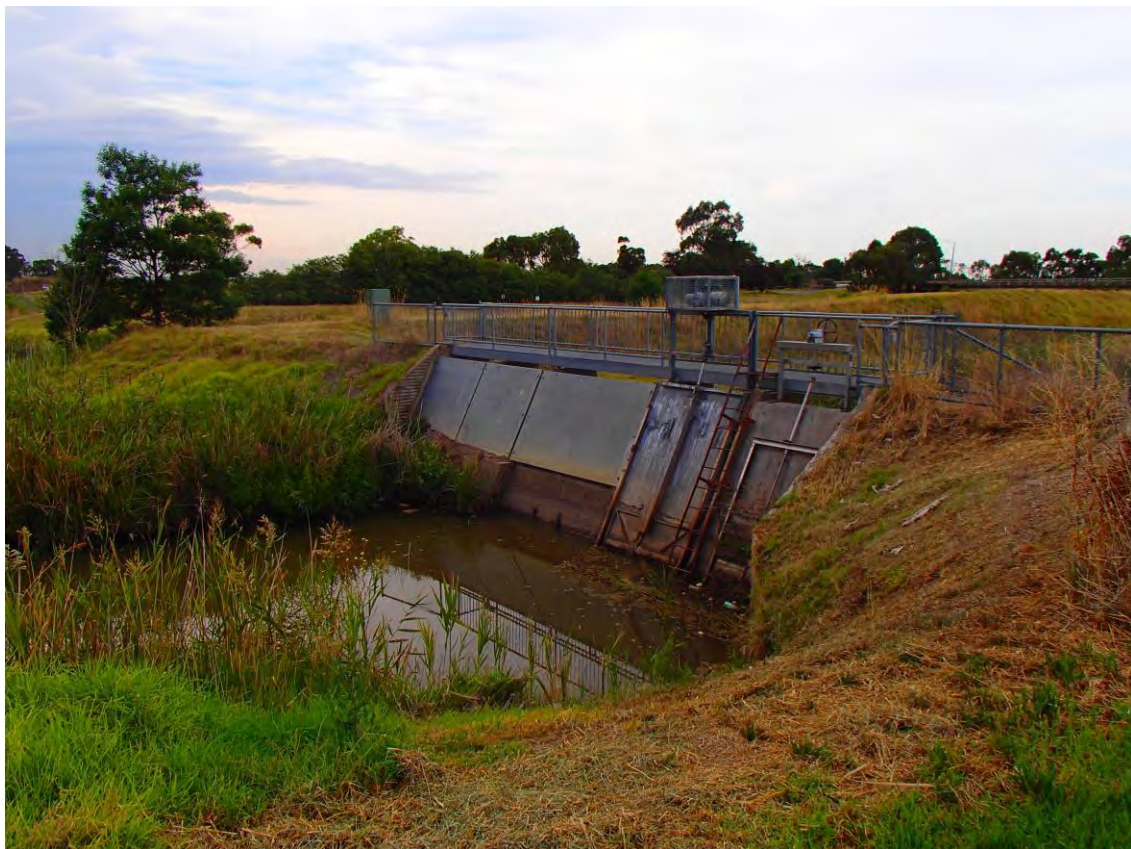
Photograph 2: Existing Melbourne Water floodgate.

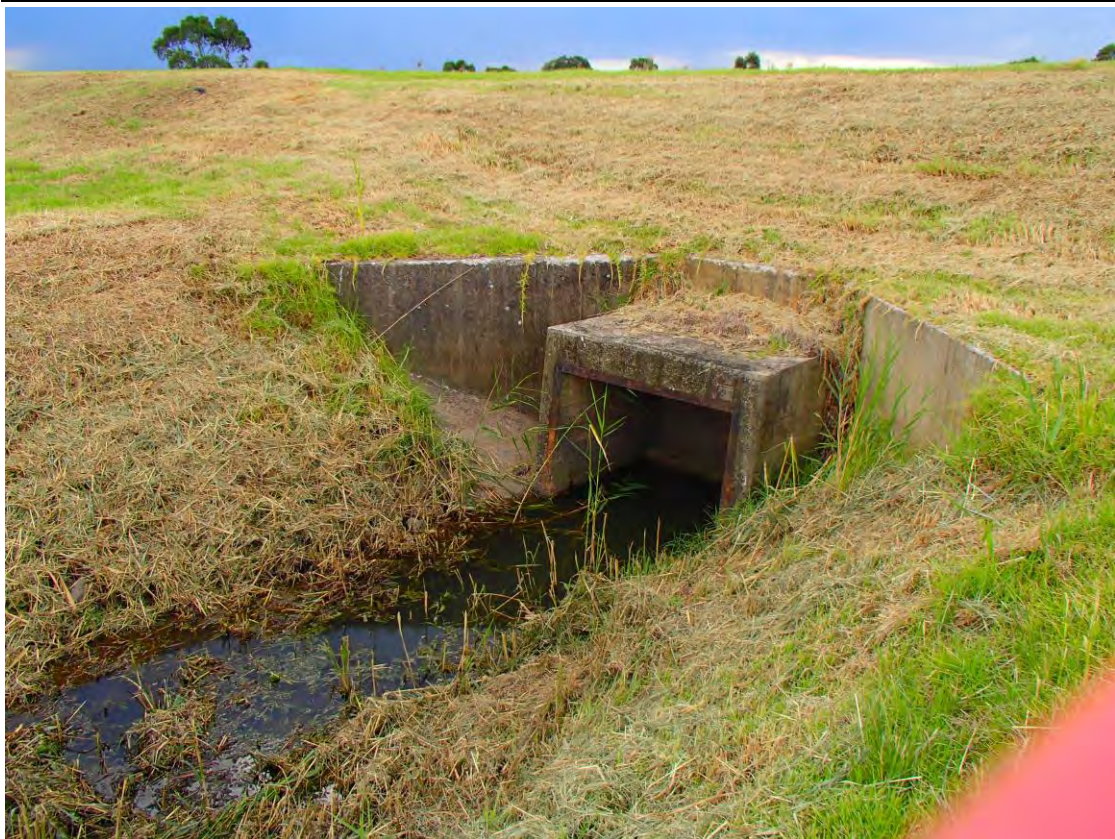
Photograph 3: Downstream Melbourne Water Syphon.

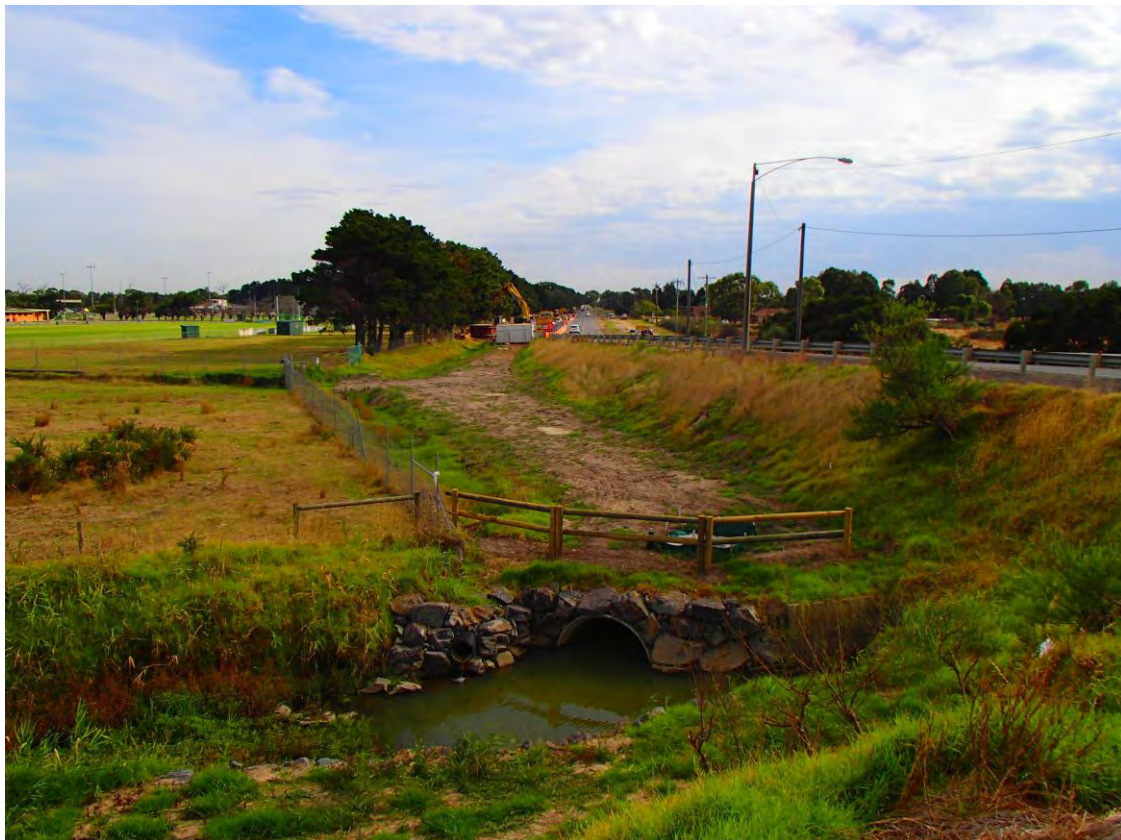
Photograph 4: Existing drainage west of Perry Rd.

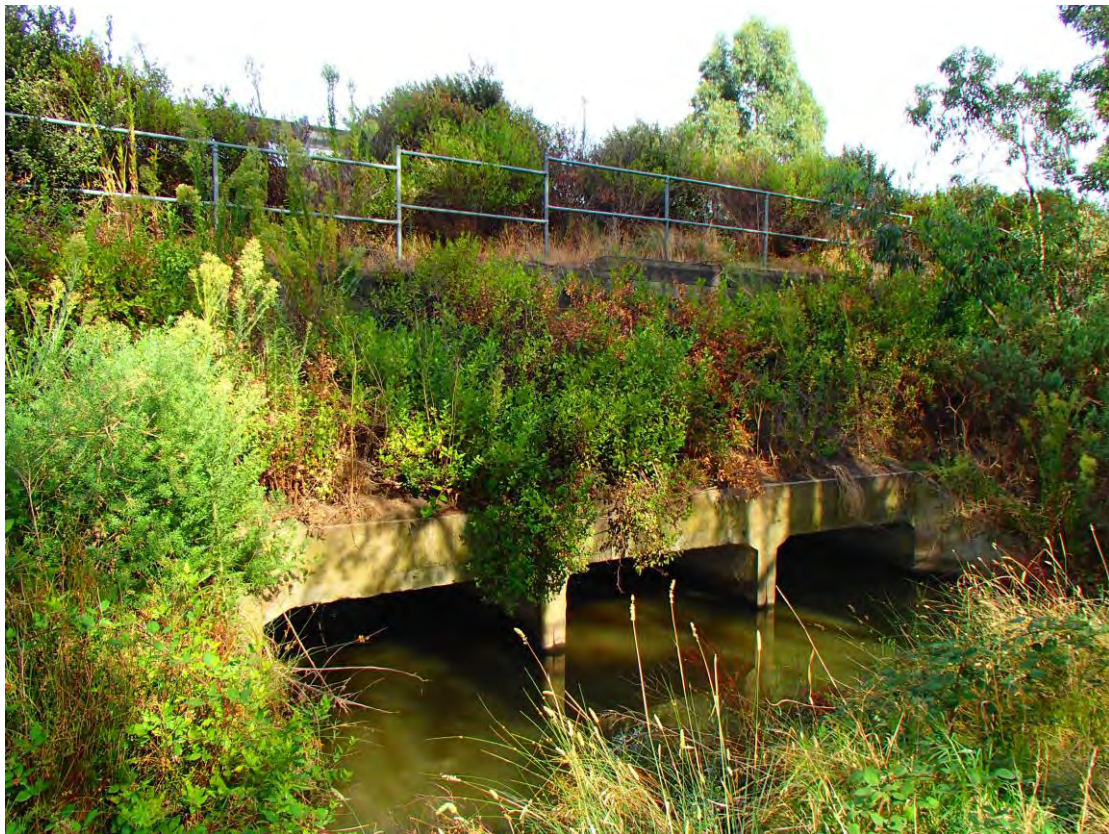
Photograph 10: Existing Perry Rd culverts.

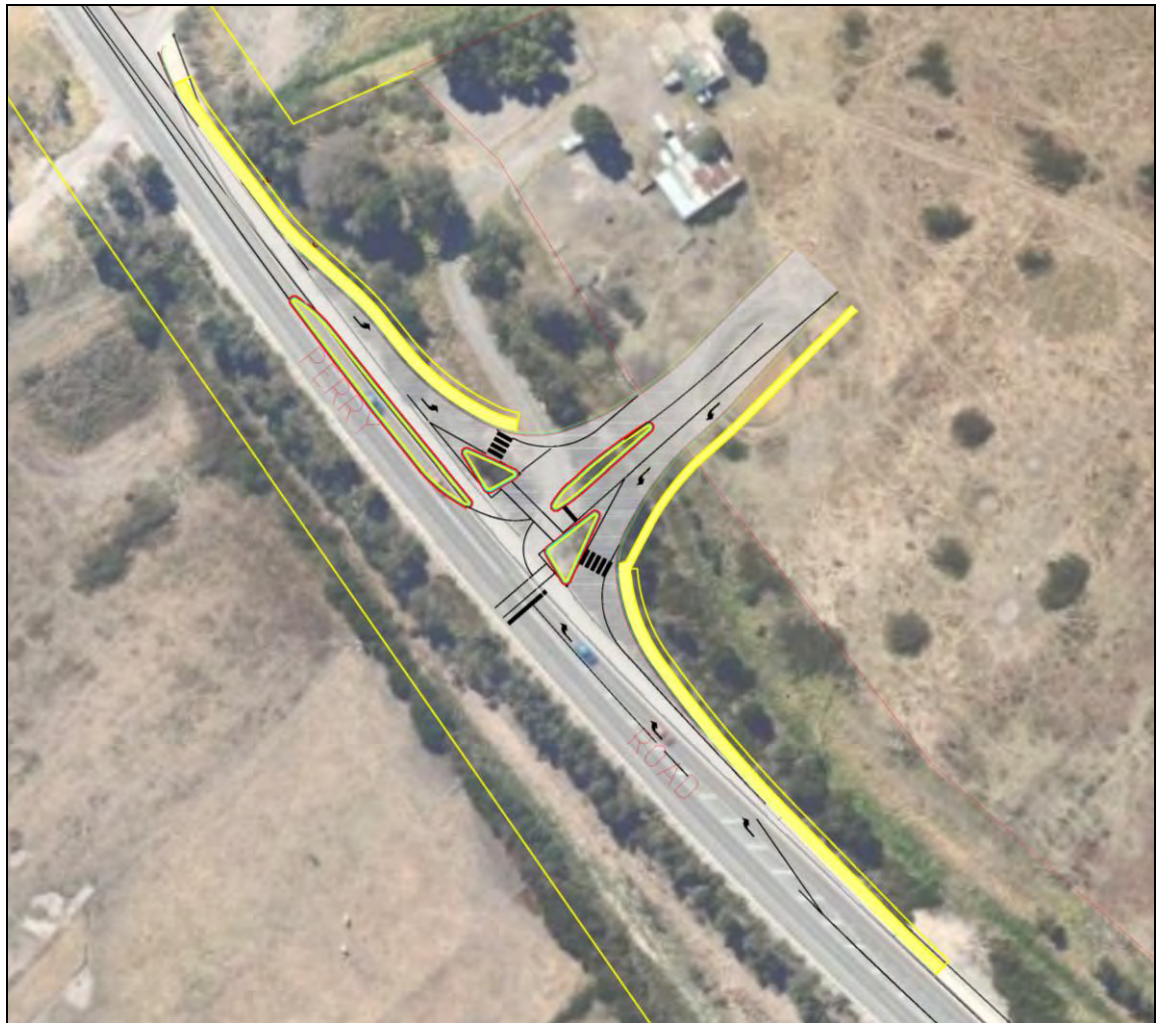
Figure 4: External Access to Perry Rd, DCE Preliminary External Intersection Design

Referring to *O'Brien Traffic's Traffic Impact Assessment, 28 March 2014* external access to the site can be obtained by constructing a signalised T-intersection on Perry Road in the south west corner of the site. The centre of the proposed intersection on Perry Road would be approx. 190m from the centre of the Worsley & Perry Road intersection, and would overlay the current existing crushed rock access as seen in Figure 4 below. The specific alignment and specifications of the external access arrangements can be obtained from the traffic report & DCE 12005.2 Functional Plans.

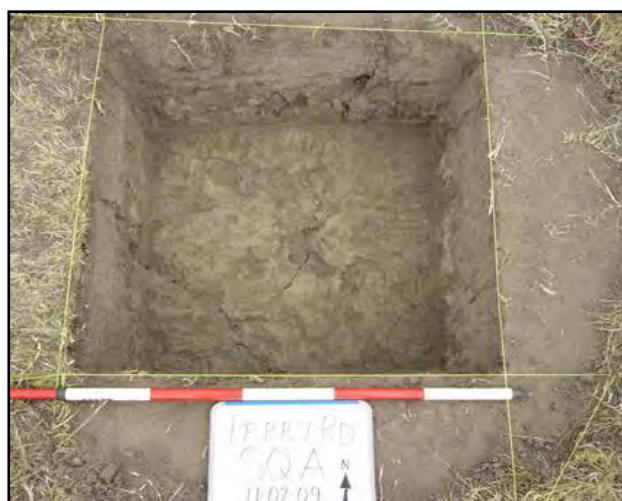
No Aboriginal cultural heritage material was identified as part of the excavations undertaken for stratigraphic test pit A.

Plate 5: Stratigraphic test pit A, basal deposit

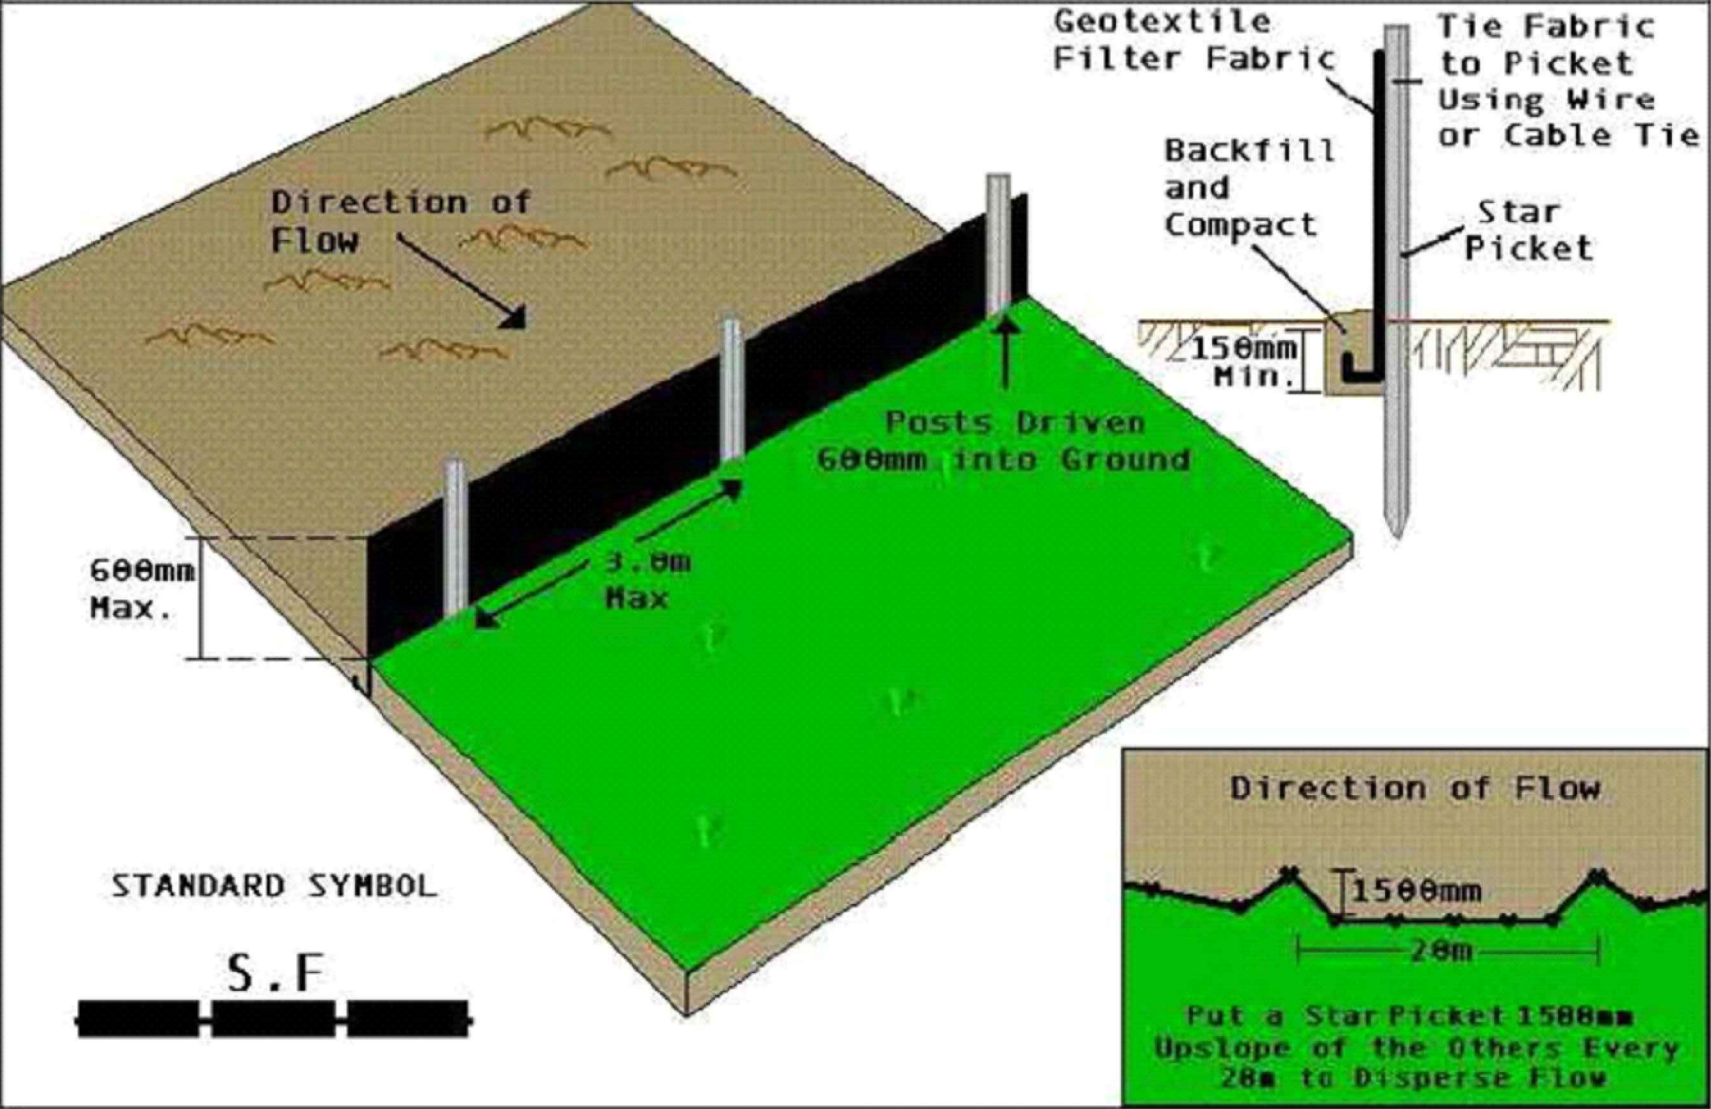
Environmental protection measures shall be constructed in accordance with the following designs.

SILT FENCE DETAIL

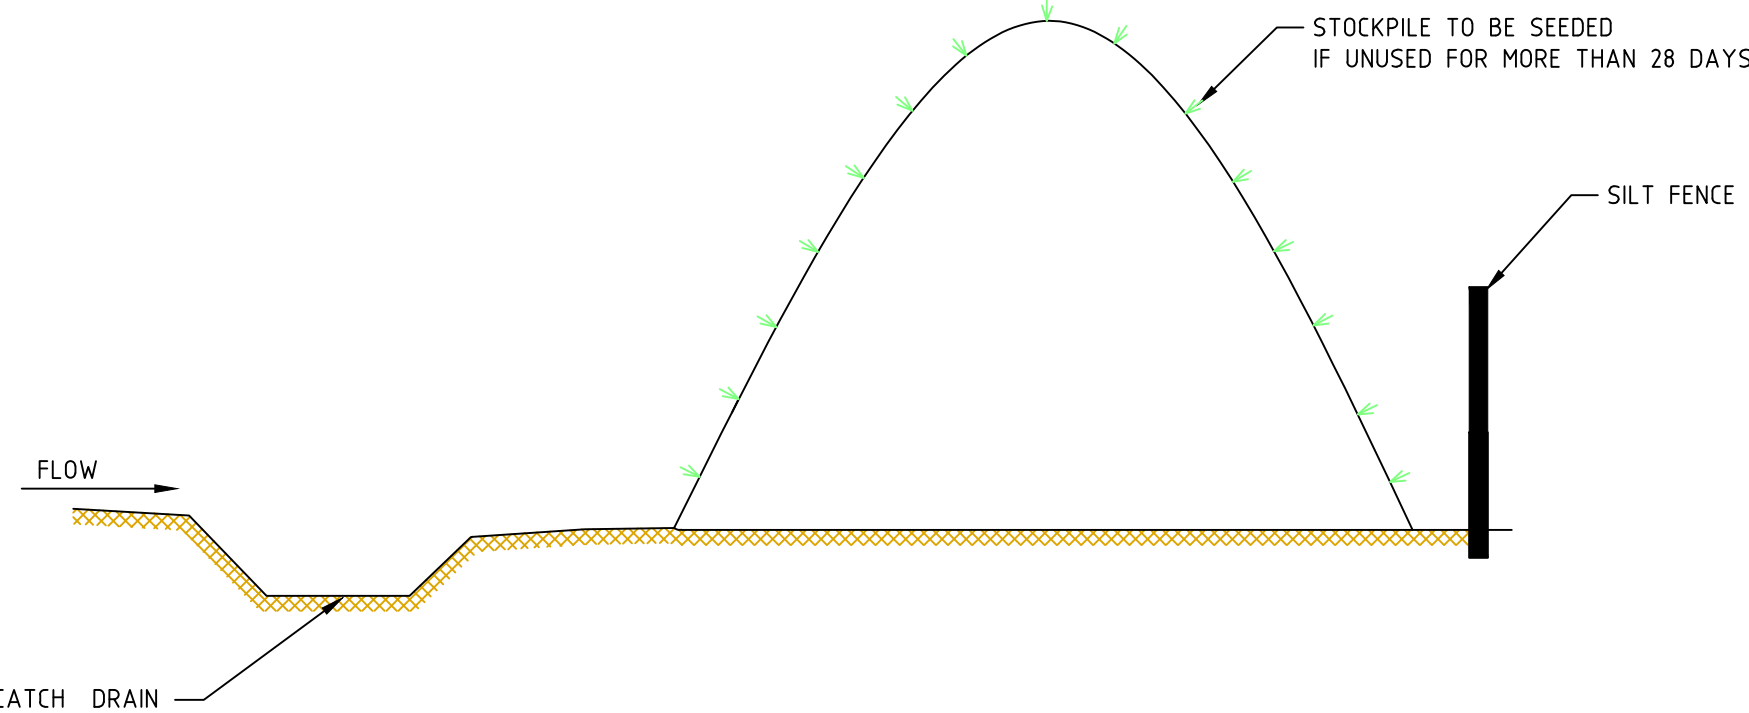
STOCKPILE MANAGEMENT

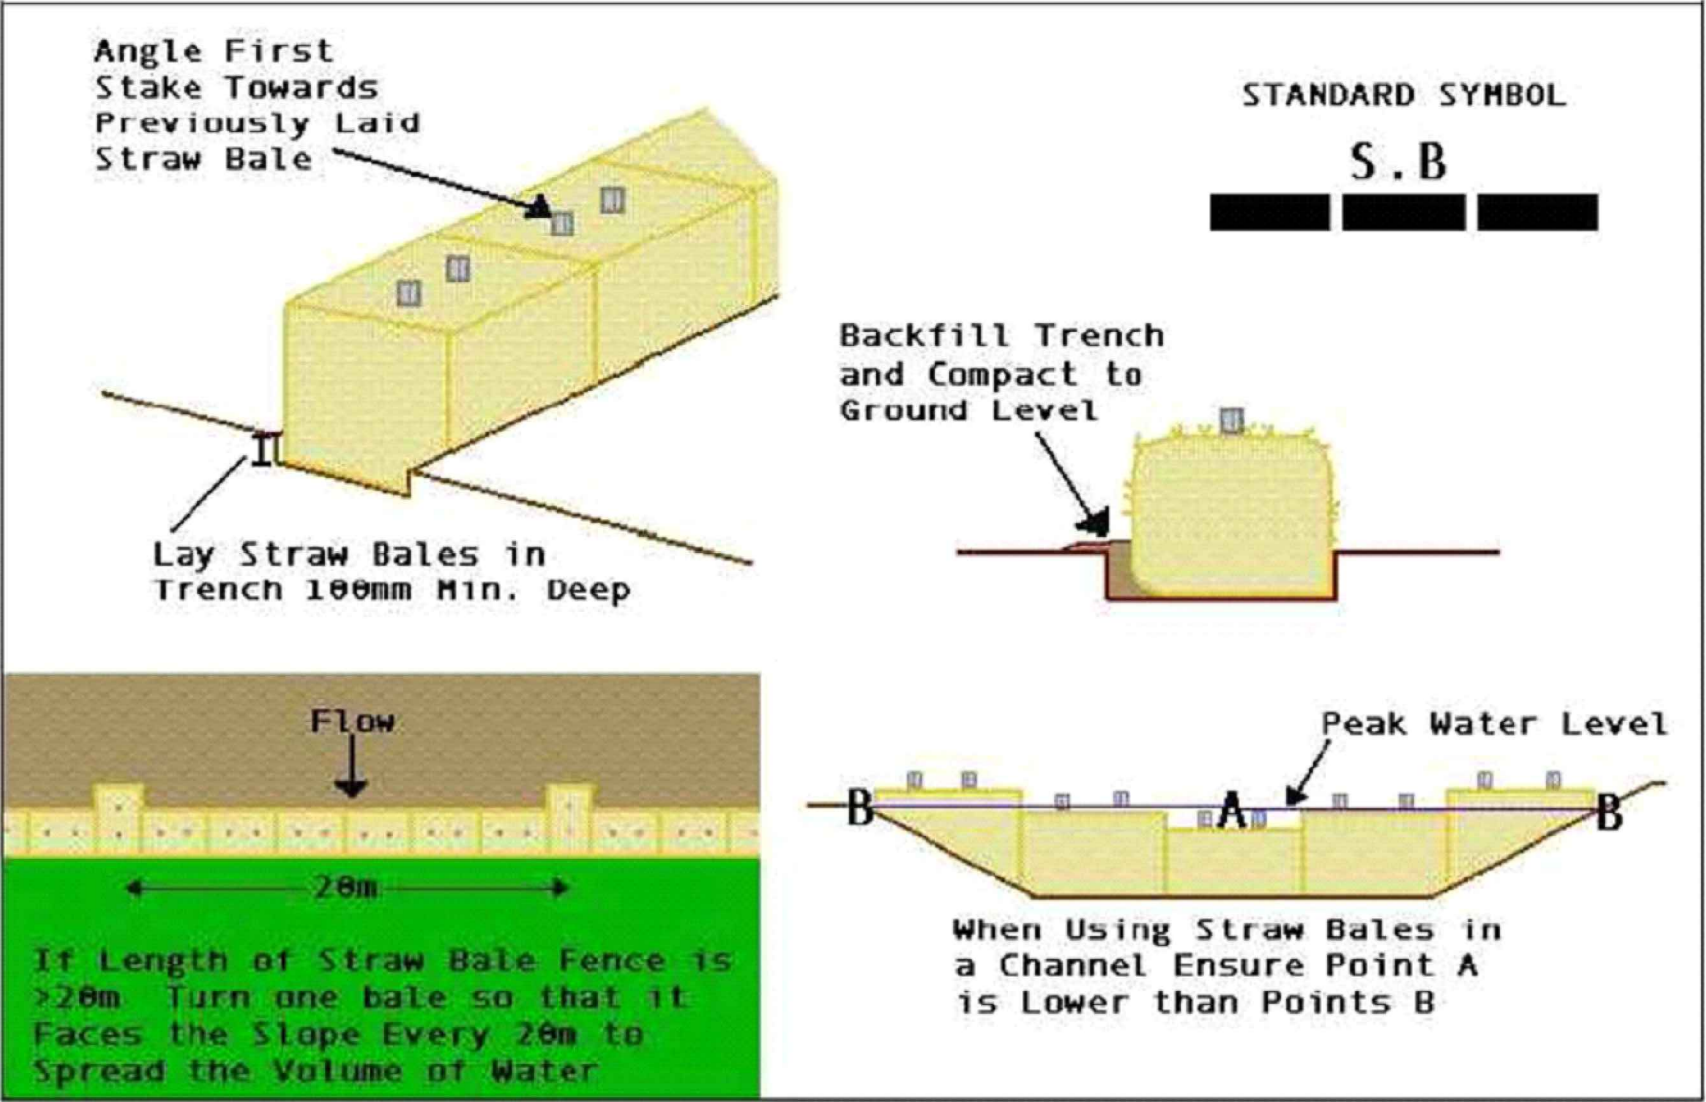
STRAW BALES

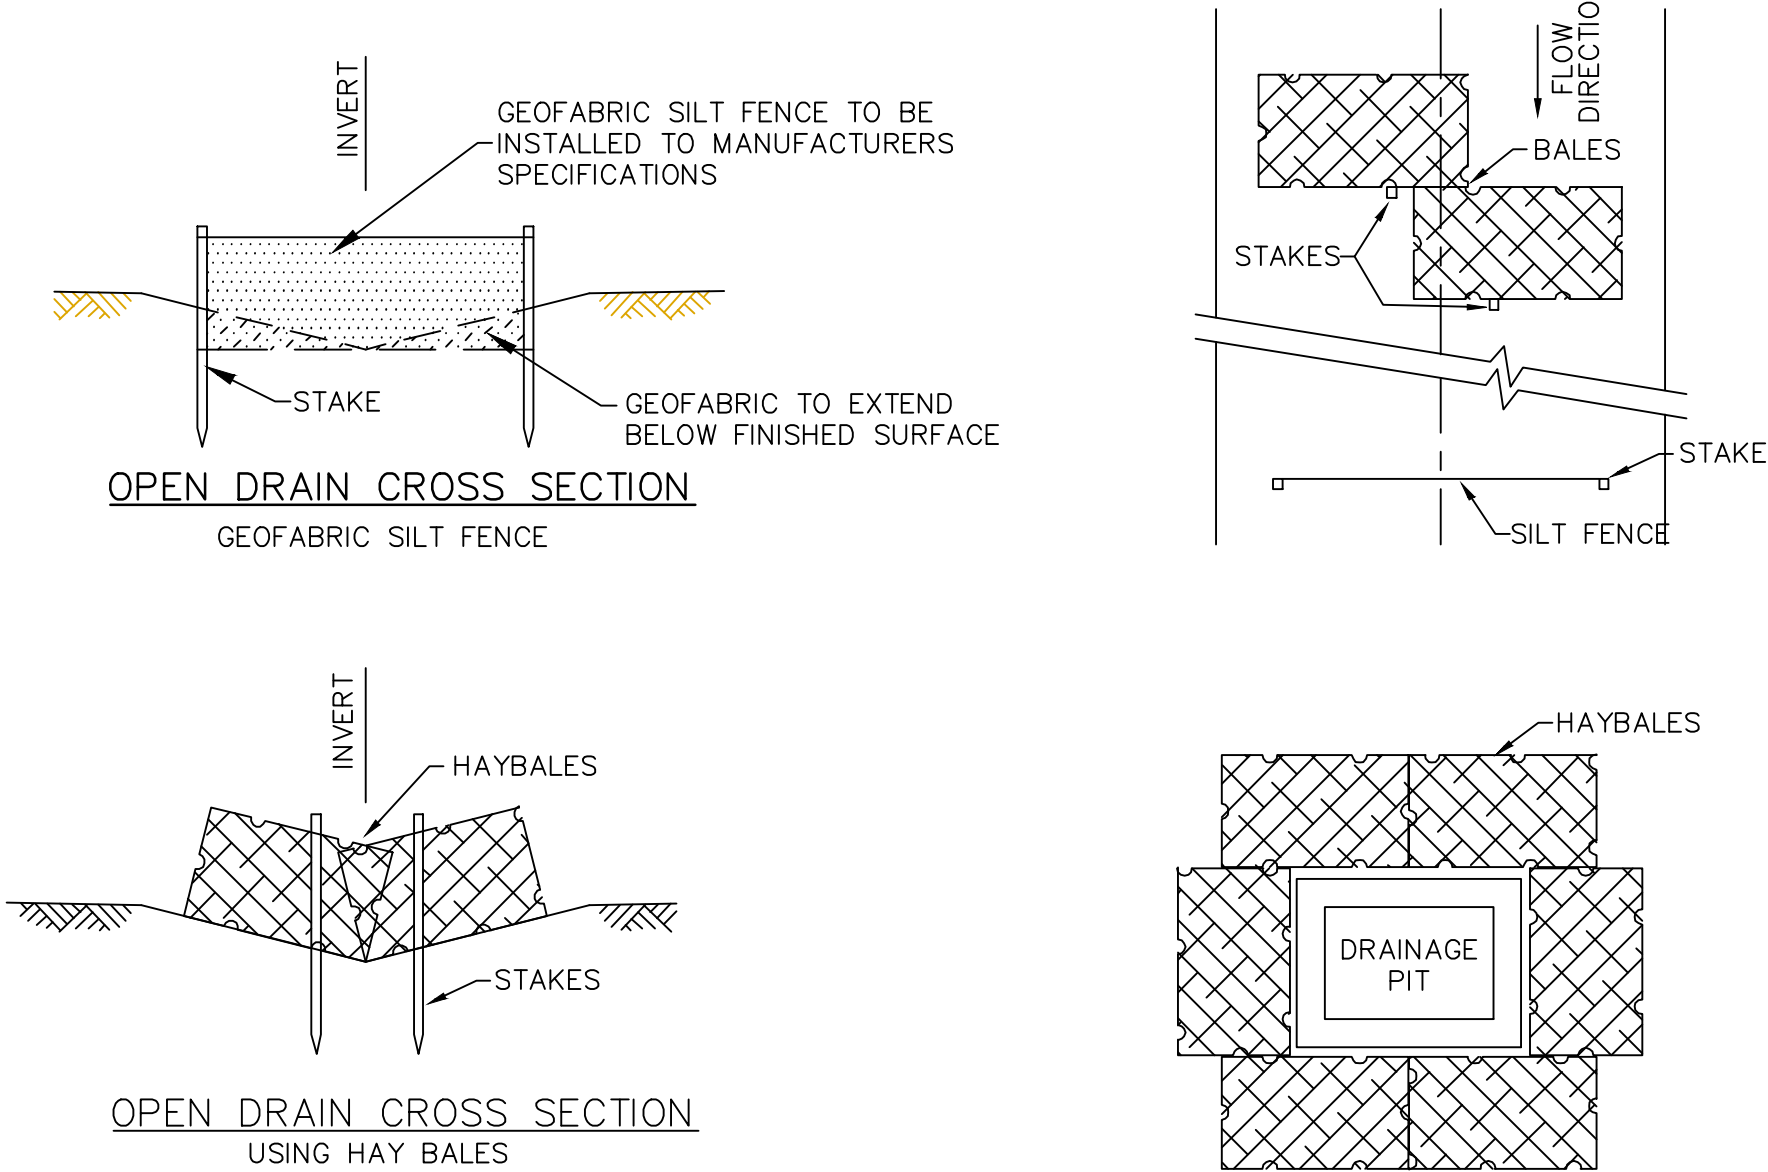
SILT CONTROL OPTIONS
NOT TO SCALE
